Alignment of CVT clutch of TrailMaster MID Go-kart

01/06/2012

This instruction is created in order to extend the life time of CVT belt and avoid unexpected burn out of belt.

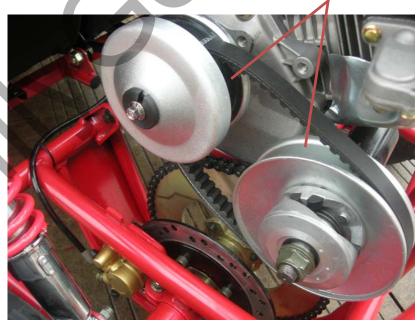
In some cases the CVT belt is suddenly damaged or worn out very quickly due to unaligned positions of front clutch and driven pulley. It's recommended to measure the <u>interior plain surface</u> with a linear ruler to ensure that both interior plain surfaces of front clutch and driven pulley are in one plane. The tolerance of planeness is +/- 2mm.
